Regasketing Reading Company GP7 621: *Cylinder Head & Cylinder Liner Removal*

For the second issue of *Shop Talk* we're going to take a look at some ongoing work we've been doing to our GP-7 Number 621. We've recently been working towards returning the 621 to service. Upon our initial inspections in 2009 we found that the engine's cooling system was compromised and that the gaskets which keep the coolant from leaking from the water jacket into the crankcase of the engine had dried out. This caused coolant to leak into the engine's oil. The fix for this is not overly expensive as far as materials go; However, there is a significant amount of labor that goes into removing all of the components from the engine to reach the leaky gaskets. After all the components are removed they need to be thoroughly cleaned and qualified before their reinstallation.

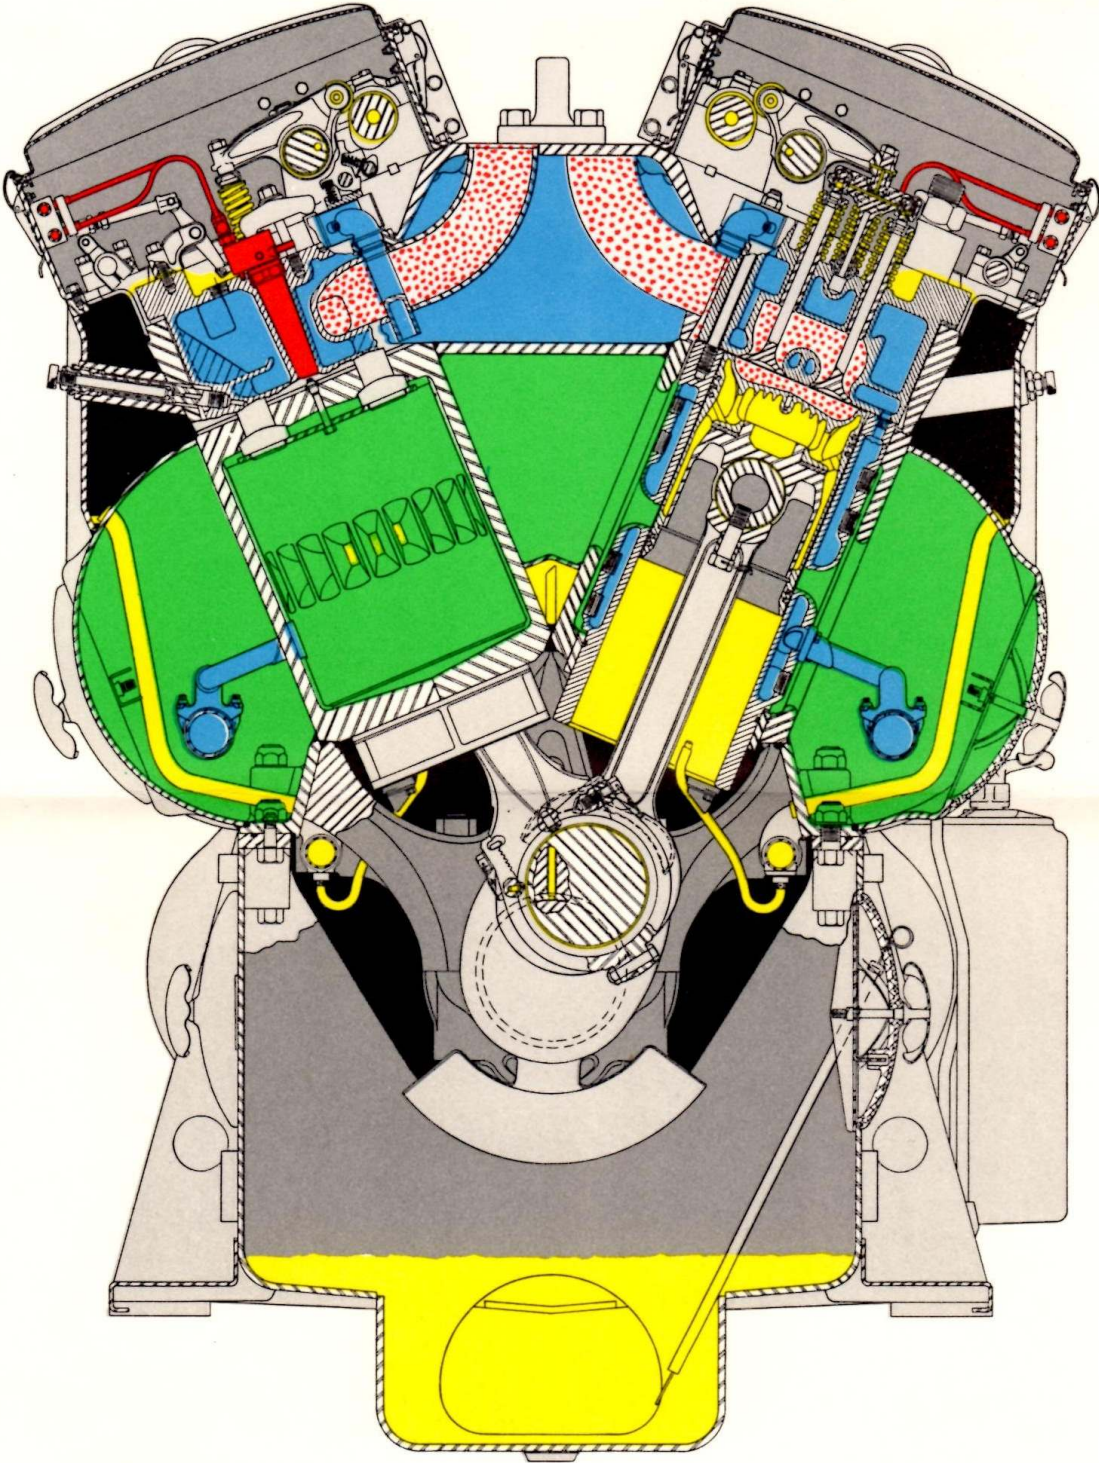
MODEL 567C SERIES DIESEL ENGINE

One of the major improvements EMD made to the 567 engine series with the 567C engine is the coolant delivery system. The photo below show a 567B engine. The early 567 engines, including the 567U, V, A , and B, used a slip fit liner assembly where each gasket surface of the liner or head slips onto a gasket seat and is held in place by crab studs. Each gasket surface is slightly smaller than the previous as you work toward the last gasket between the liner and crankcase. This set-up was prone to failure as gaskets dried out. The gaskets are large O-rings that slip onto the liner or head. We'll look at the gaskets in greater detail later. The advances of the 567C are shown on page 4 and illustrate the mechanical flanged fittings used in all EMD engines after the 567C. This design is much easier to repair and provides a superior means of connection.

SCAVENGING AIR LUBRICATING OIL EXHAUST WATER FUEL OIL

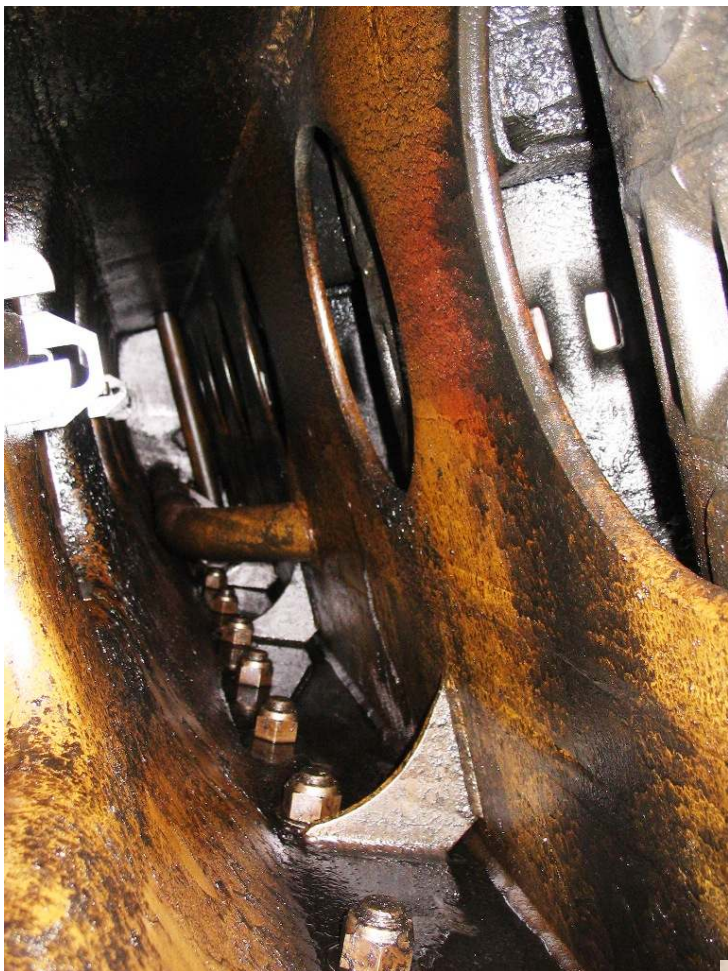
(TOP LEFT) This view shows what the air box looks like in RDG 621's 567B 1500 HP roots blown variant of the 567 engine series. You can see the water manifold feeder pipe about halfway down the air box turning inwards toward the block. This feeds inlet water to the manifold which runs the length of the diesel engine, supplying the liners and heads with coolant. The liners seat onto the top and bottom of the water manifold with the slip fit style gaskets mentioned on page 3.

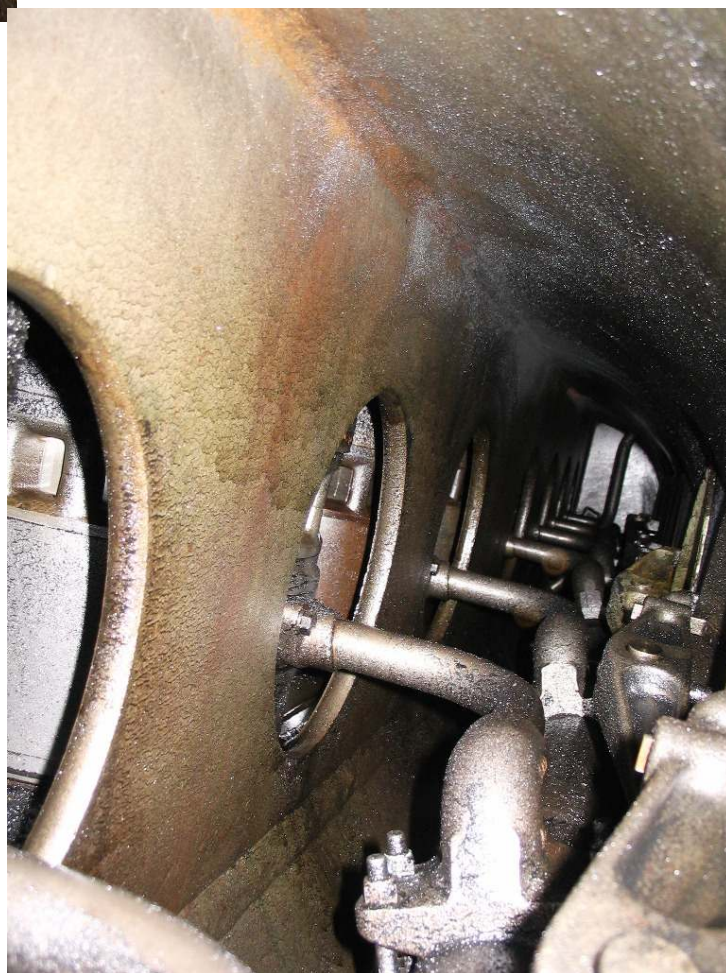
(BOTTOM RIGHT) This view looks into RDG 3640's air box. The 3640 has the 567D3A, a 2500 HP turbo-charged variant of the 567 engines series. The difference in engineering designs for water supply are quite visible. In 567C or later versions like the 567D3A seen here, EMD ran the water manifold supply inside the air box and used the small jumper pipes with flanged fittings to supply the liners with coolant. This proved to be much less maintenance-intensive; if one of the jumpers began to leak, only the jumper pipe had to be removed and regasketed and not the entire power assembly.

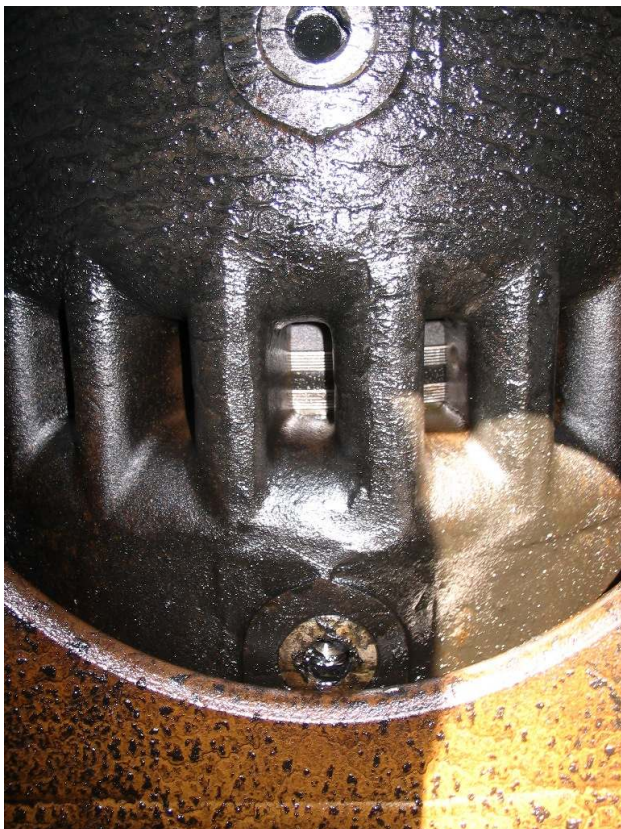
(TOP LEFT) This is looking directly at the side of one of the 567B liners through the air box inspection cover.

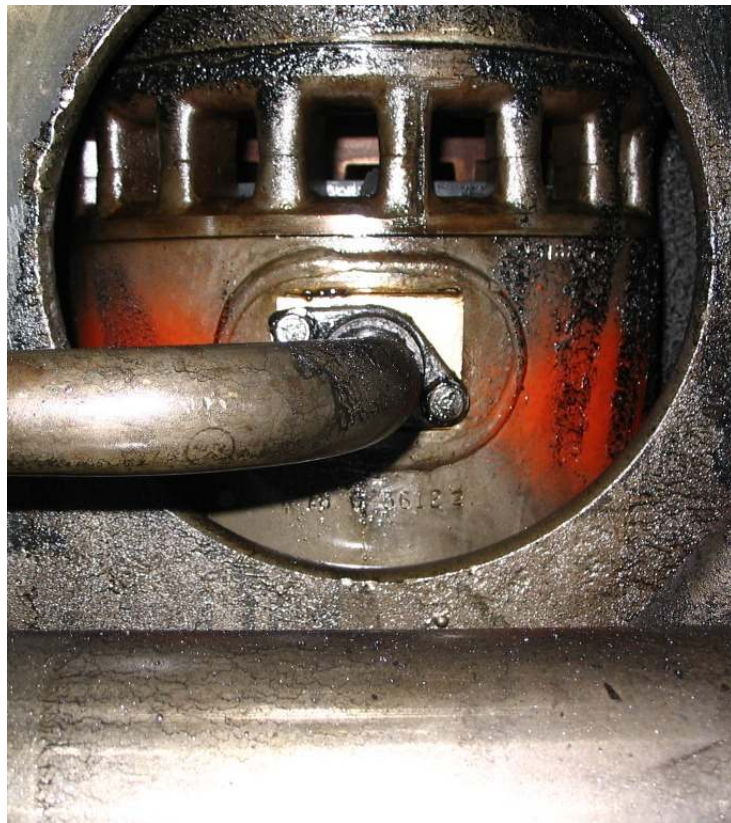
(TOP RIGHT) In this view, you can see the difference when looking at the 567D3A's liner through the air box inspection cover.

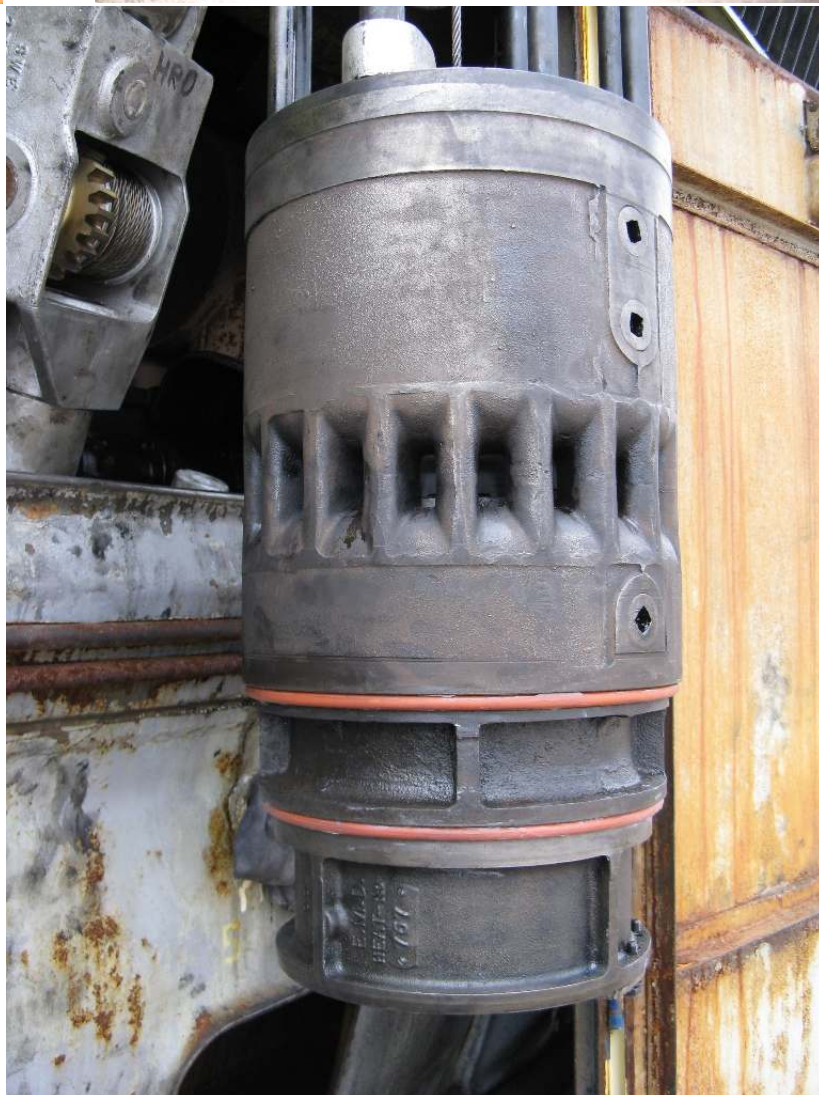
(BOTTOM RIGHT) Here we see one of the 567B liners hanging from the top deck crane, ready to be reinstalled into the engine block after being cleaned and qualified. The two orange O-rings toward the bottom of the liner bracket the water intake for the 567B. These are the gaskets that failed on the 621's engine. The old gaskets came off in multiple pieces. It was no wonder they no longer sealed properly and allowed water to leak in to the crankcase.

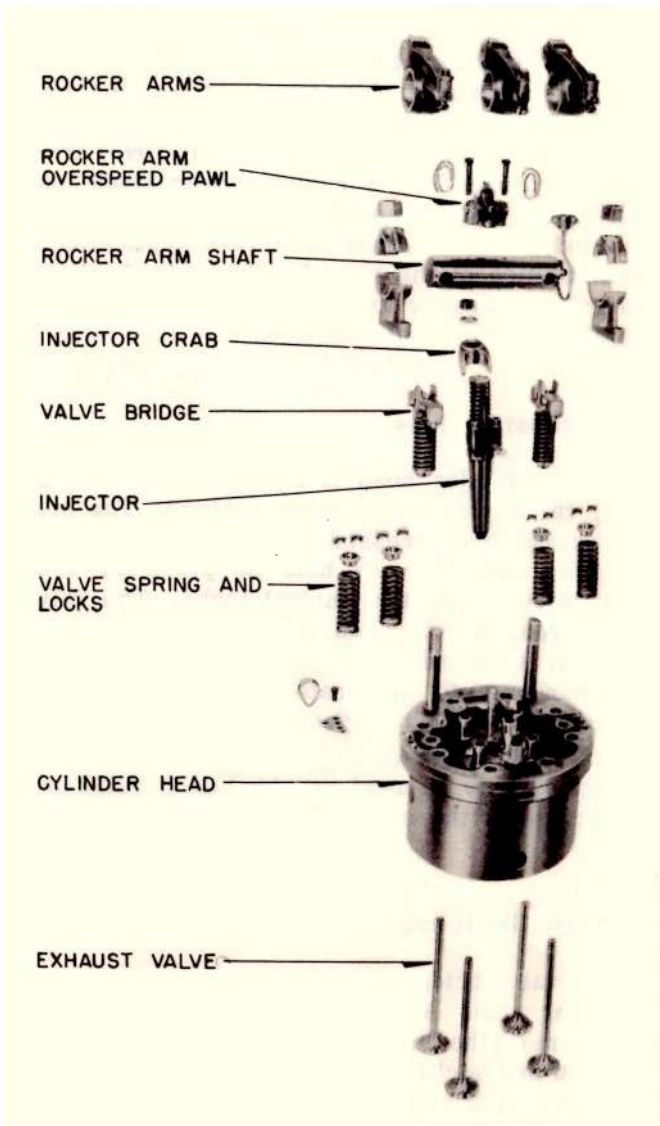
(TOP) This is a photo from the 567B service manual. It shows all the components that go with the cylinder head. After removal, we clean each part and inspect them individually to ensure they are suitable for use.

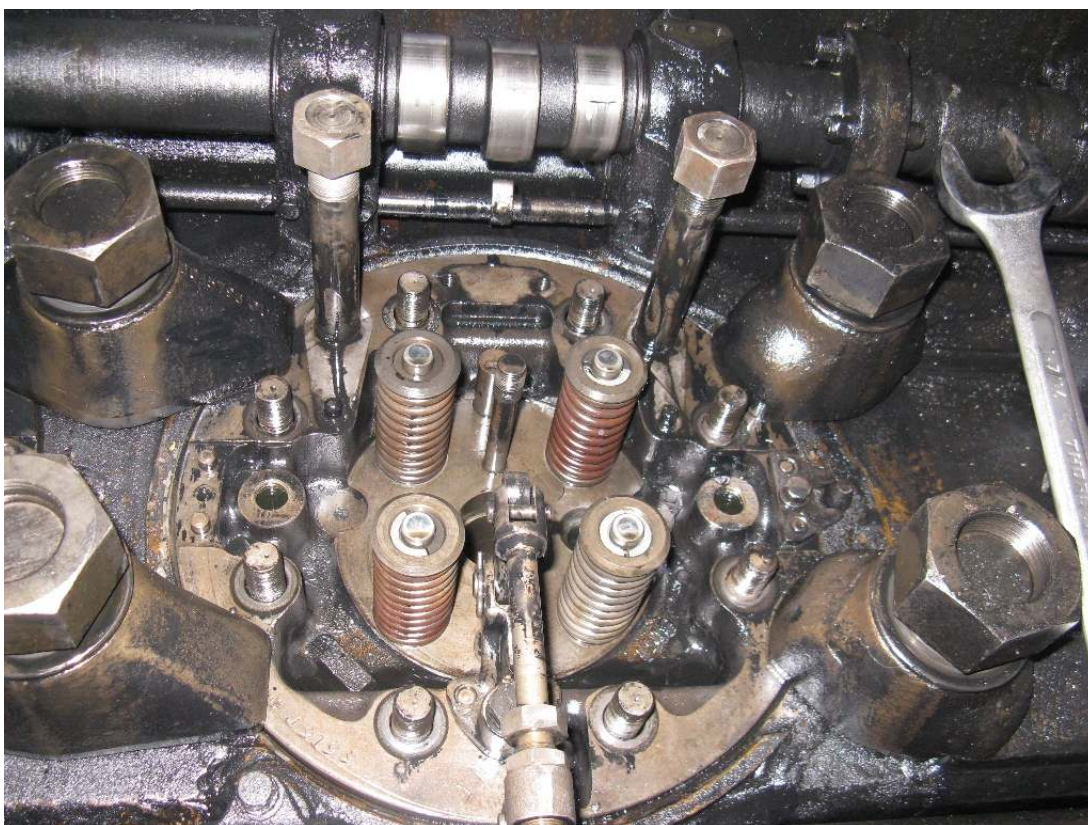
(TOP) After all the “jewelry” was removed from the heads, we loosened the crab nuts. These are torqued up to 1,800 ft-lbs of torque. The crabs are what keep the power assemblies in the engine block. A torque multiplier is used to loosen the nuts. The one seen here is a 4:1 ratio.

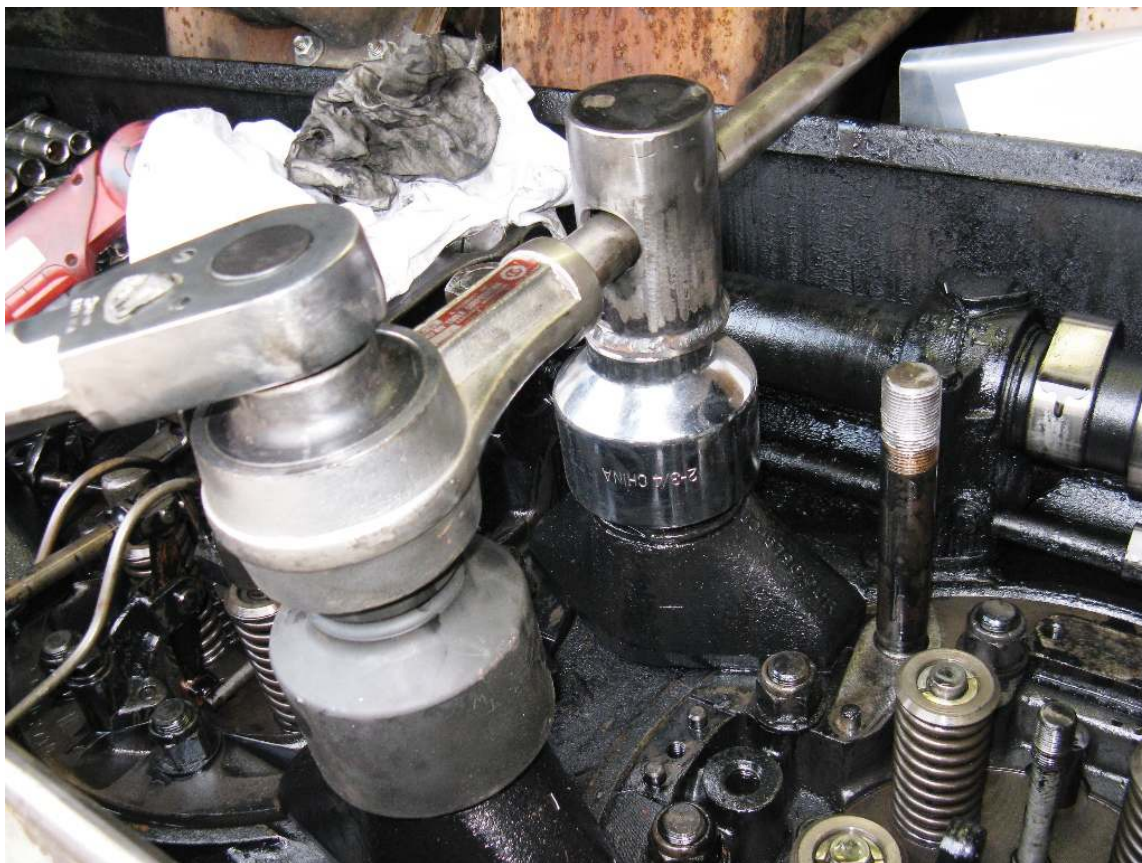
(BOTTOM) Another view of another set-up for removing the crabs. Note the PVC crab stud protectors we created to ensure we didn’t accidentally damage any of the crab studs as they remained in the engine block.

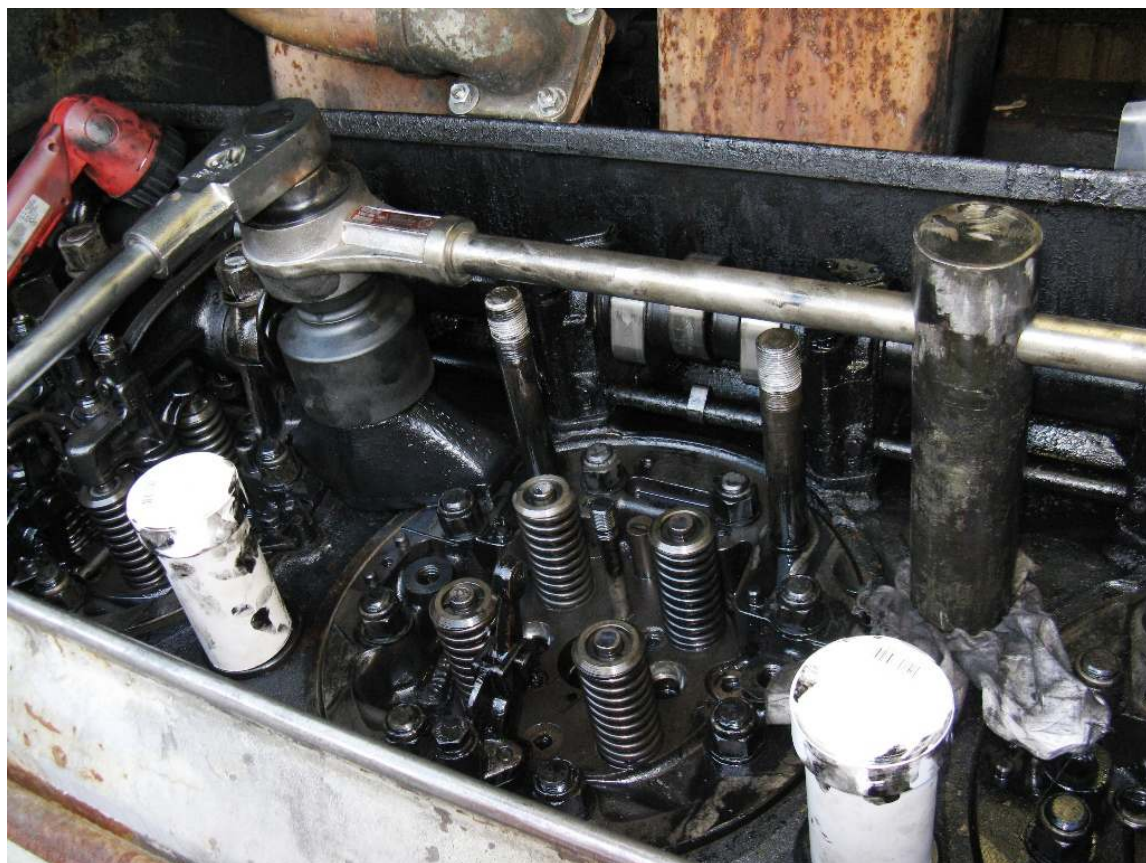
(TOP) Next we install our custom-made head jacking tool. This is designed to jack the head free of the liner. It attaches to the head and uses jacking screws to lift the head out of the liner's seat.

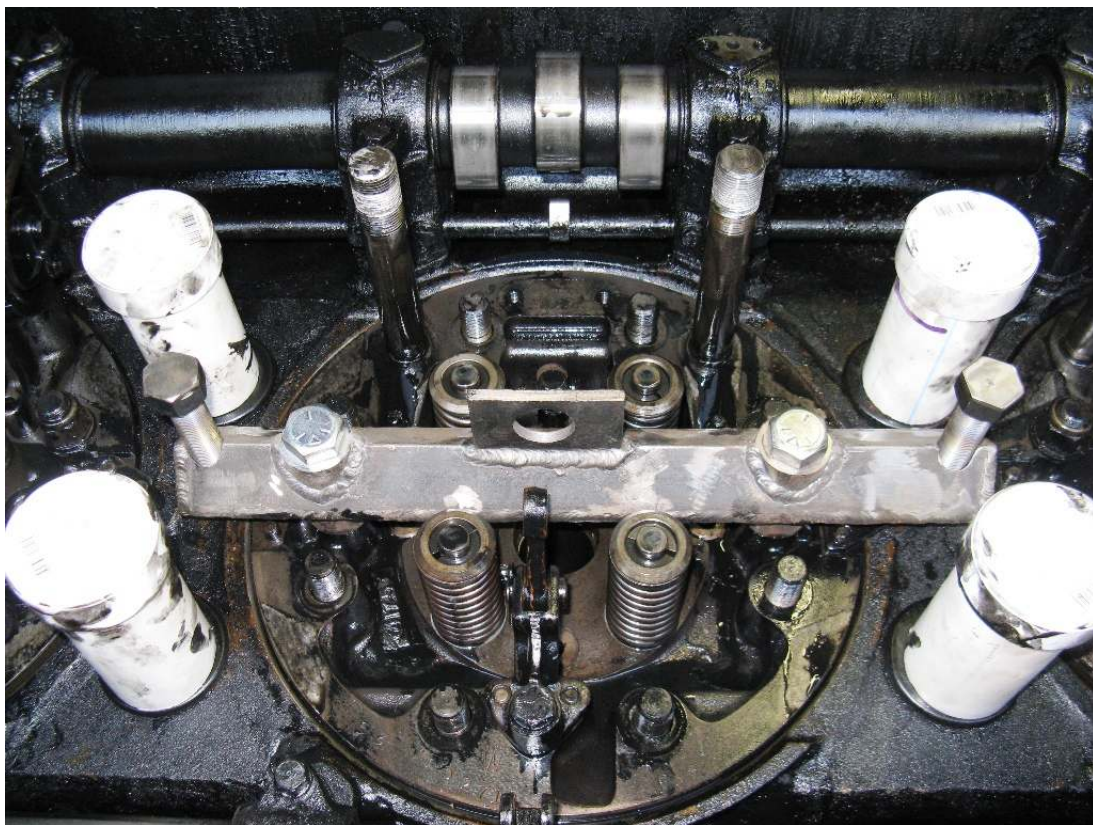
(BOTTOM LEFT) In order for the head jacking tool to work, the liner itself needs to be properly secured in its seat, so we designed another tool, our own custom liner anchor tool. This tool keeps the liner in its seat and allows the head to be jacked free of the liner.

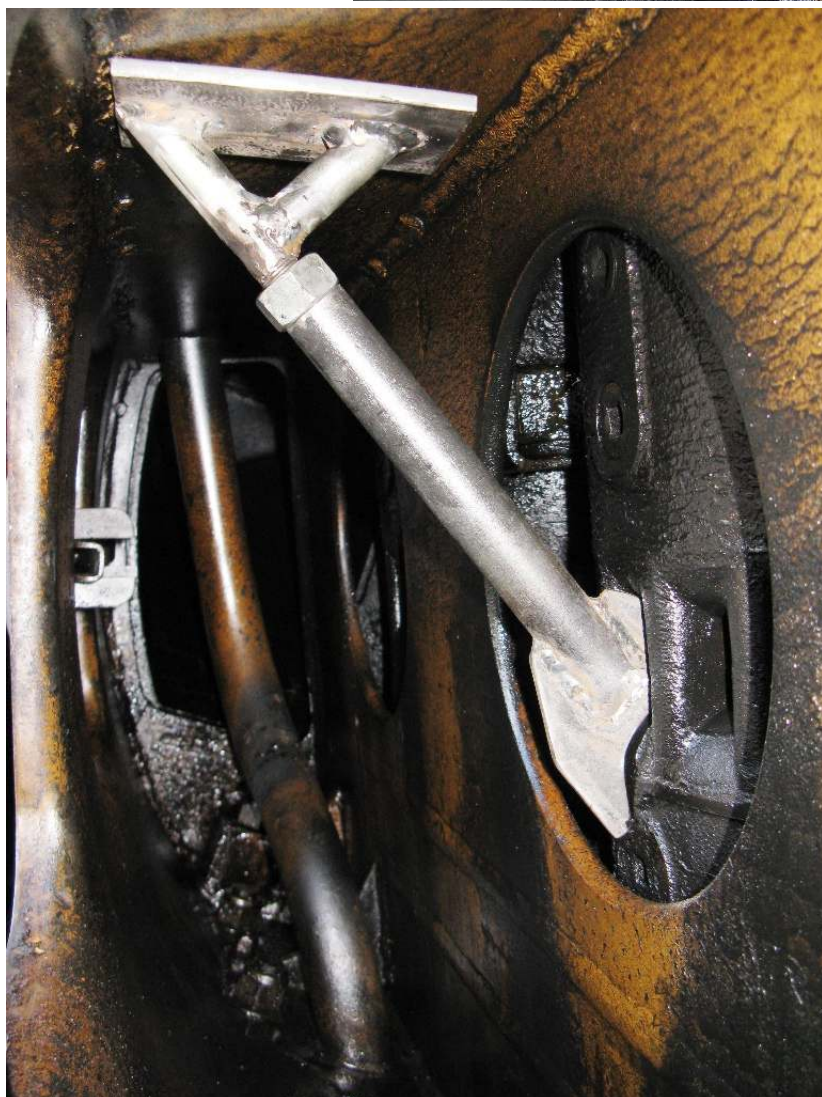
(BOTTOM RIGHT) Here we see a head jacked up and free of the head gasket and liner.

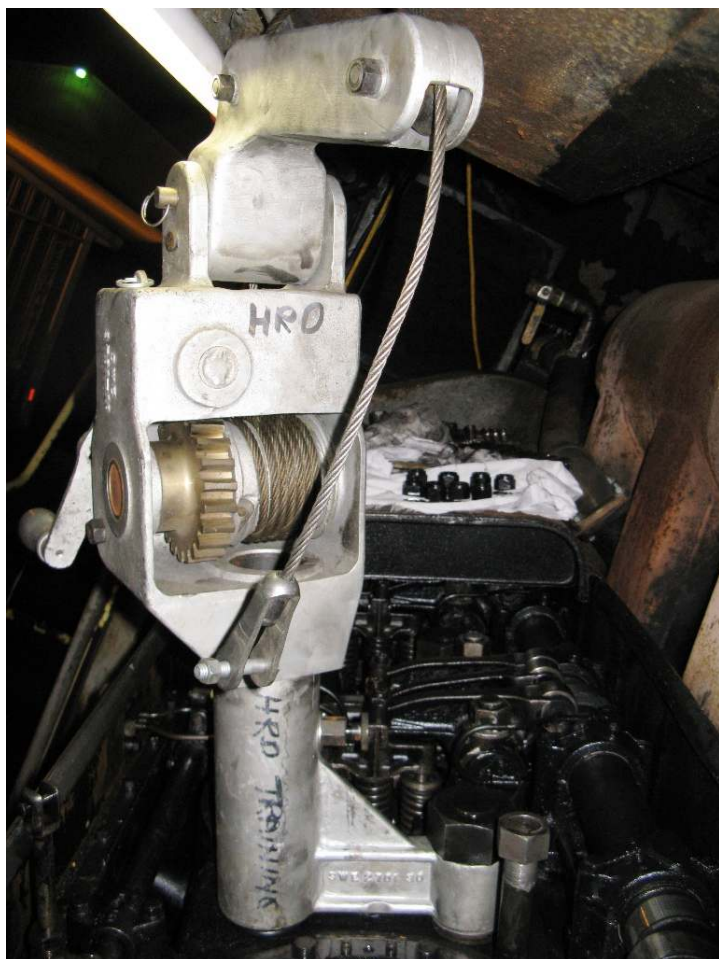
(TOP LEFT) Once the head is free of the liner, the top deck crane is fastened to the crab studs.

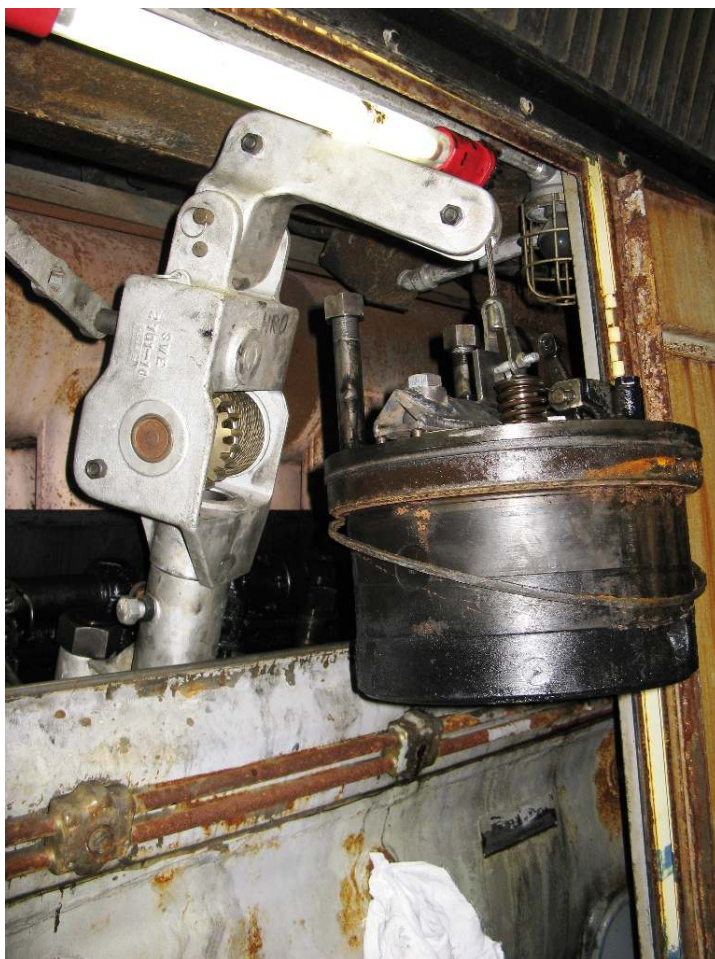
(TOP RIGHT) With the crane installed, the head can be lifted and swung clear of the engine block.

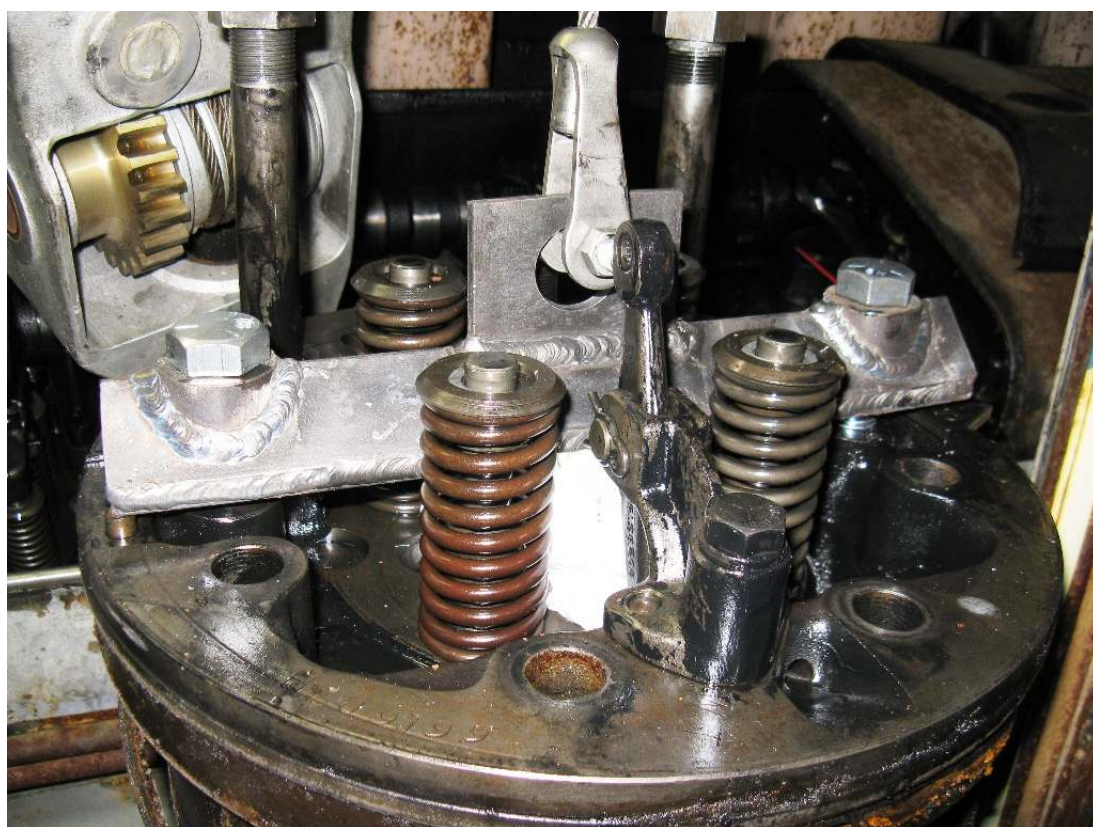
(BOTTOM) A custom head lifting tool was made in order to lift the heads out of the block. They are then set down on the running board and picked up by the handrail crane to be lowered to the ground.

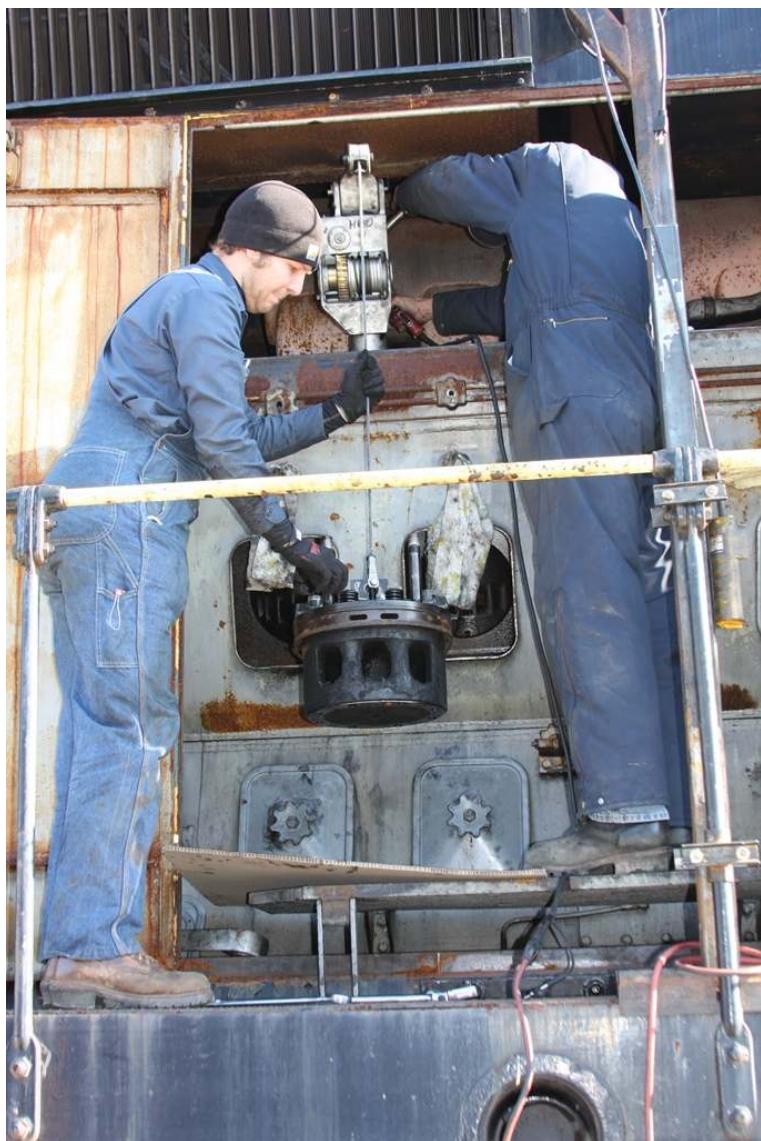
(TOP) The head being lowered to the running board by the top deck crane. All the engine parts are set on a protective piece of cardboard to make sure none of the surfaces are damaged.

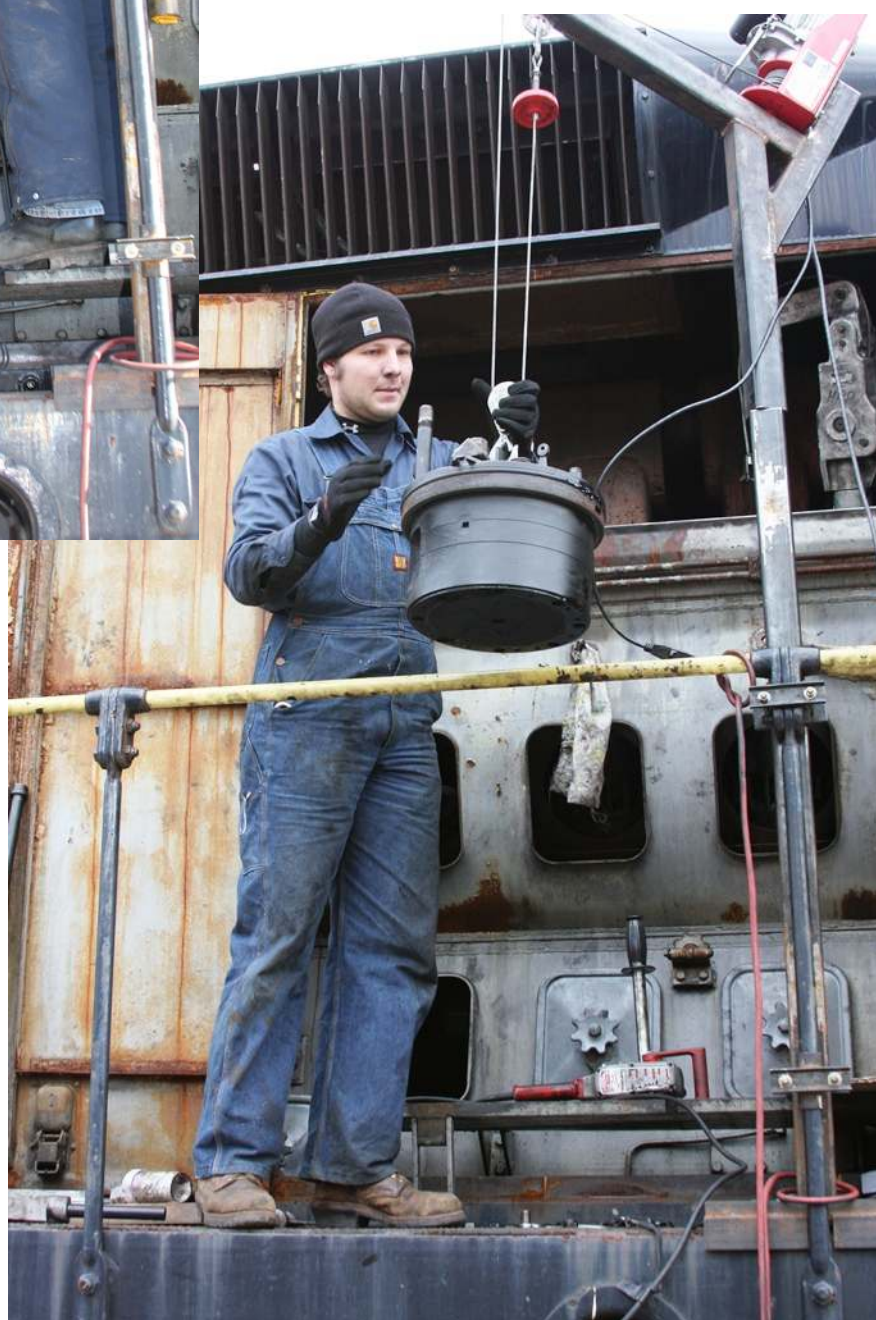
(BOTTOM) After the head is lowered to the running board by the top deck crane, it is then picked up by the handrail crane. The handrail crane is then used to lower the head to the ground where we can then use a hand truck to move it into our work area. The handrail crane is an invention of the MP&RE Department and was shown in the first issue of MP&RE *Shop Talk* being used to remove the 103's reverser.

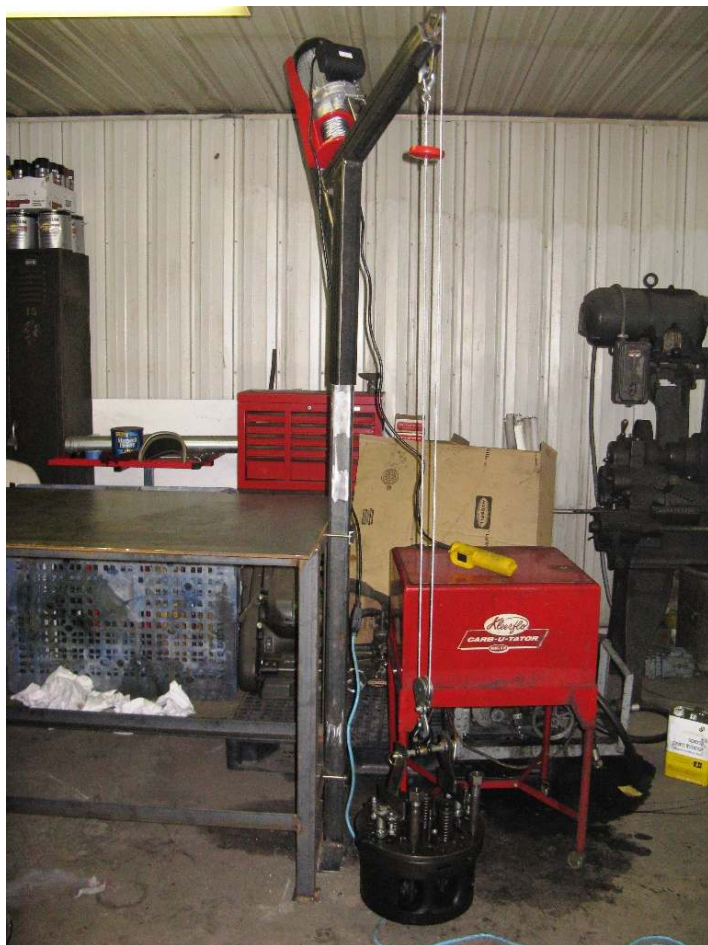
(TOP LEFT) After the head is moved inside to our work area, it can be picked up again by the multipurpose crane now being used as a work bench crane. Here, a head is seen hanging a few inches off the shop floor.

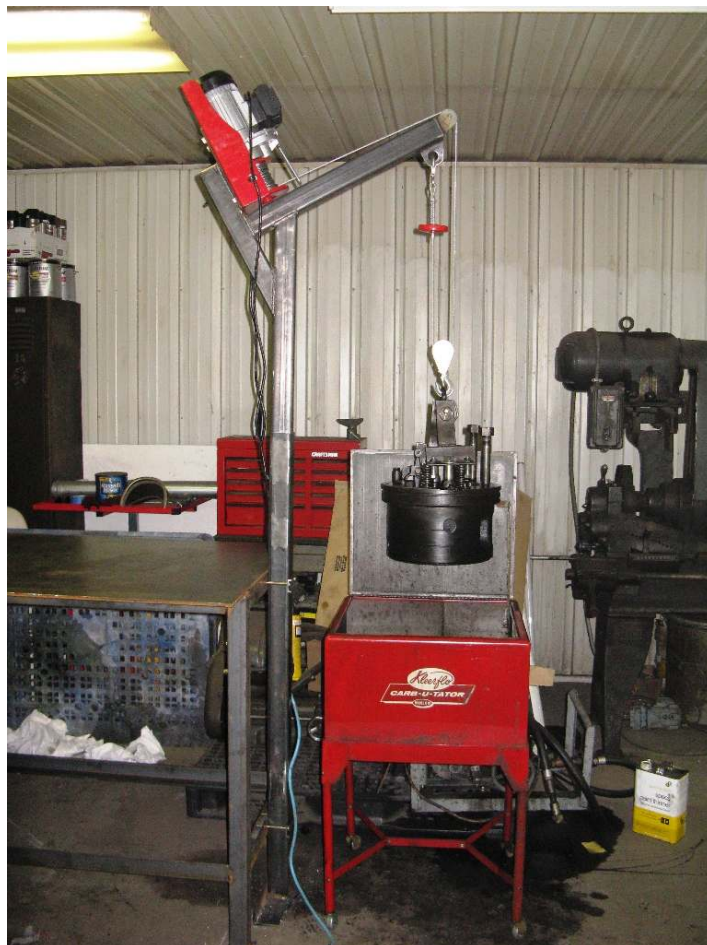
(TOP RIGHT) Once lifted by the crane, the head can be swung and dipped into the parts washer to soak in cleaning solution for cleaning.

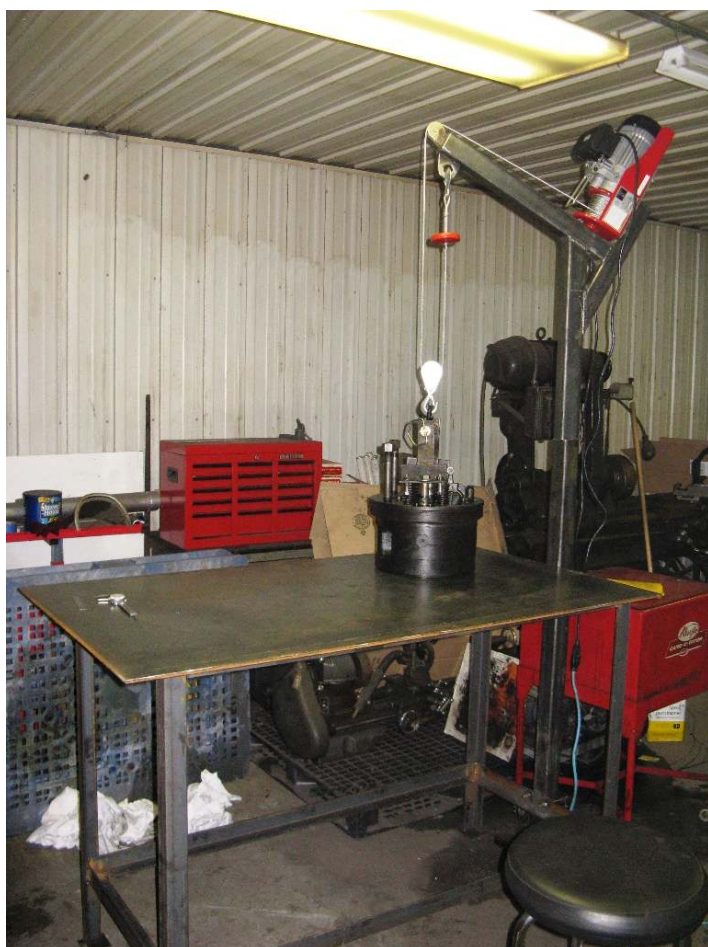
(BOTTOM LEFT) The head can then be swung over to the work bench to be disassembled and cleaned.

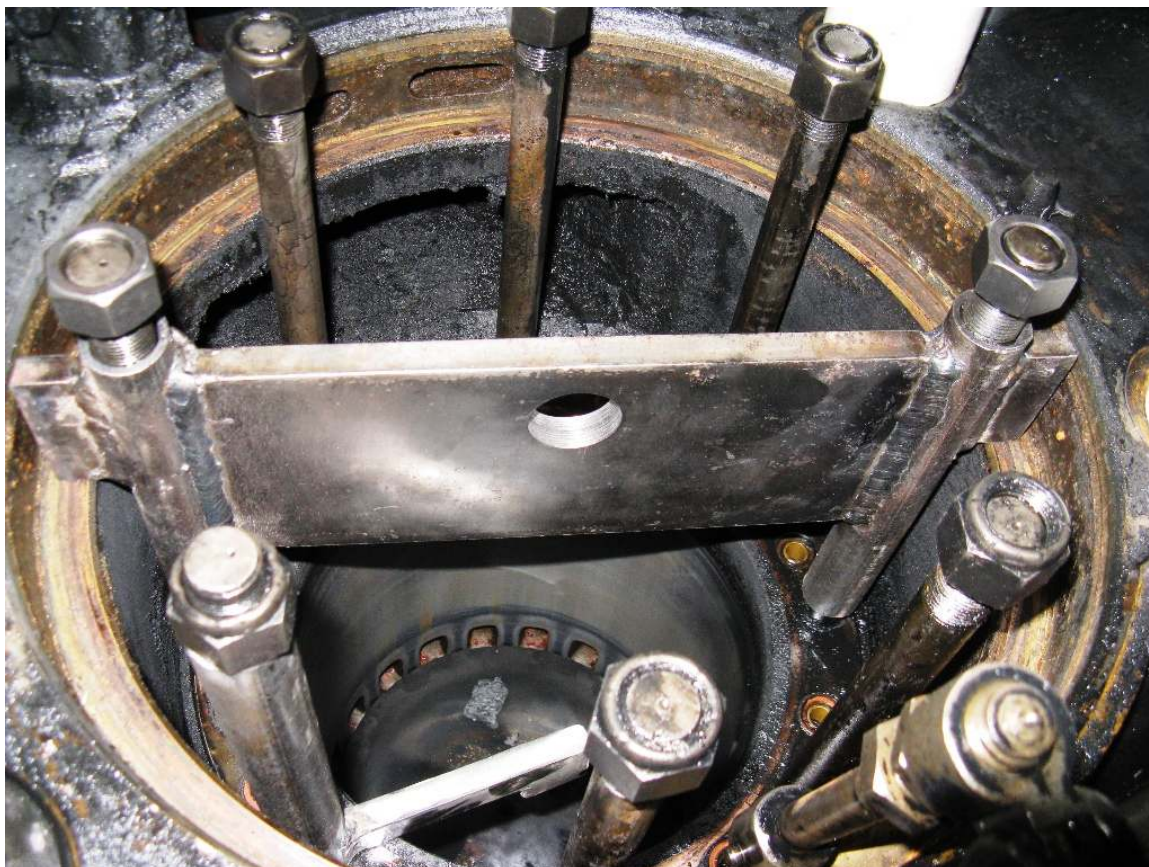
(TOP) With the head removed, we also removed the liner anchor tool. Then the liner jacking tool is used to jack the liner free of its gasket seats.

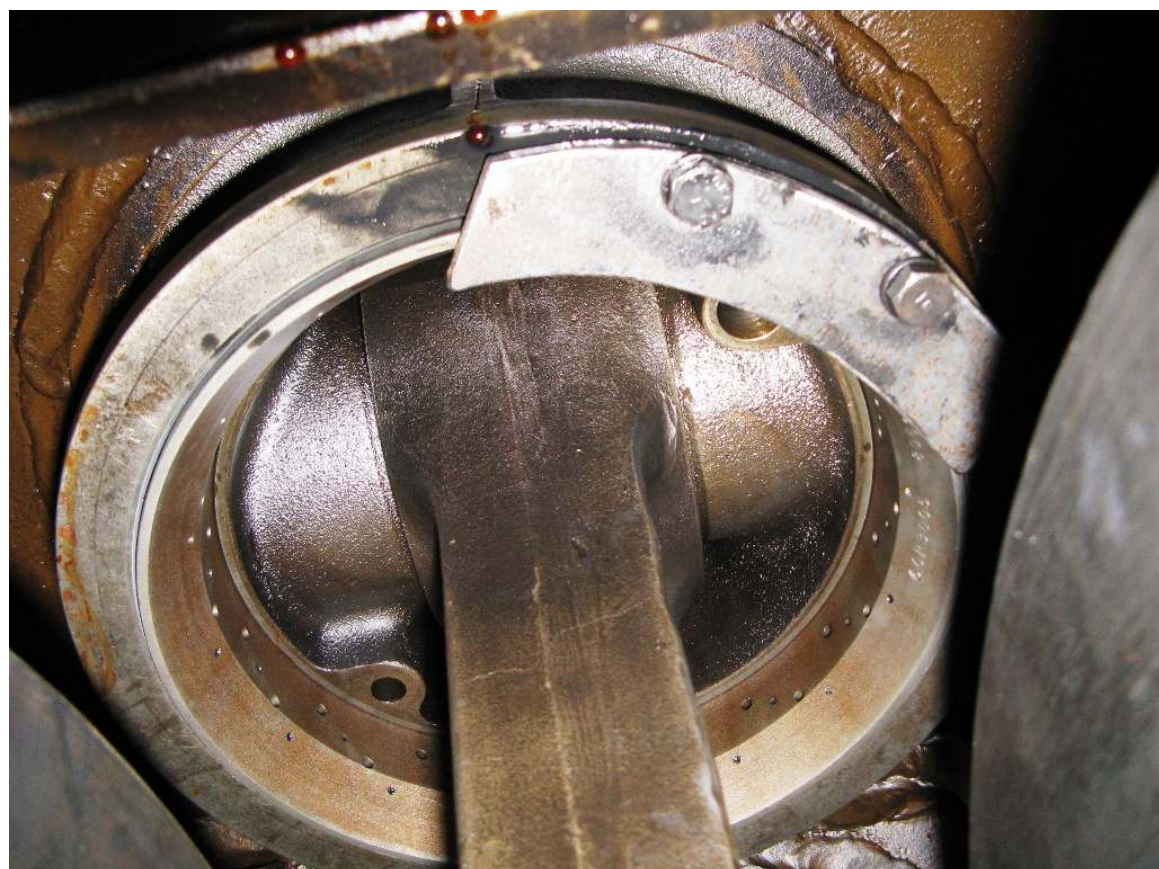
(BOTTOM) Also installed where the pee-pipe had been is the piston blanking plate. This custom-made plate is designed to keep the piston in the liner while allowing the piston pin carrier to pass by after the carrier snap ring has been removed. Leaving the pistons in the liners saved us a lot of time.

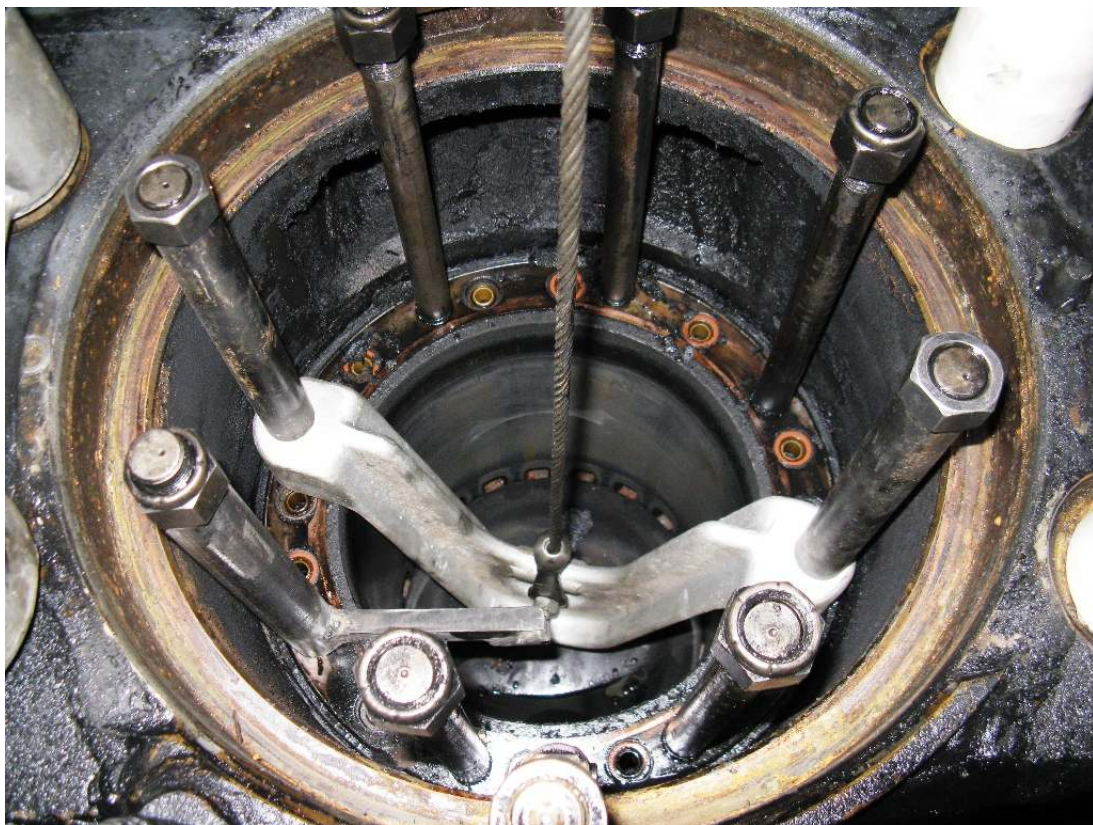
(TOP) With the liner free and the piston secured, the top deck crane is hooked up to the liner with the liner lifting tool.

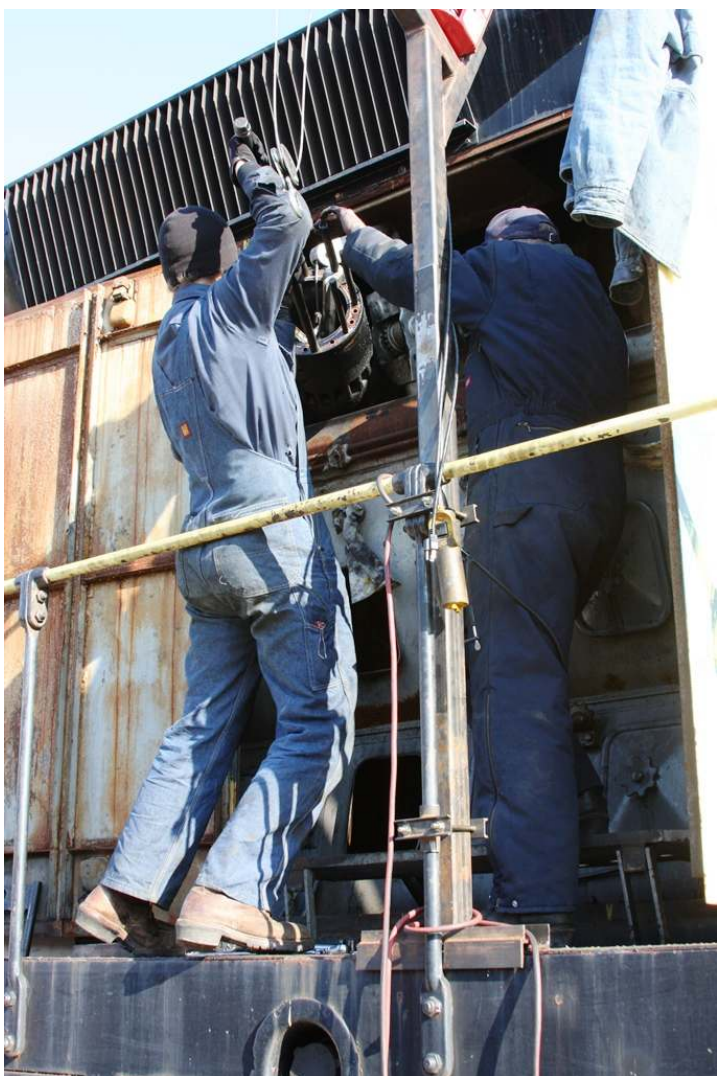
(BOTTOM LEFT) The liner is manipulated out with another tool invented by the MP&RE Dept., the liner maneuvering tool.

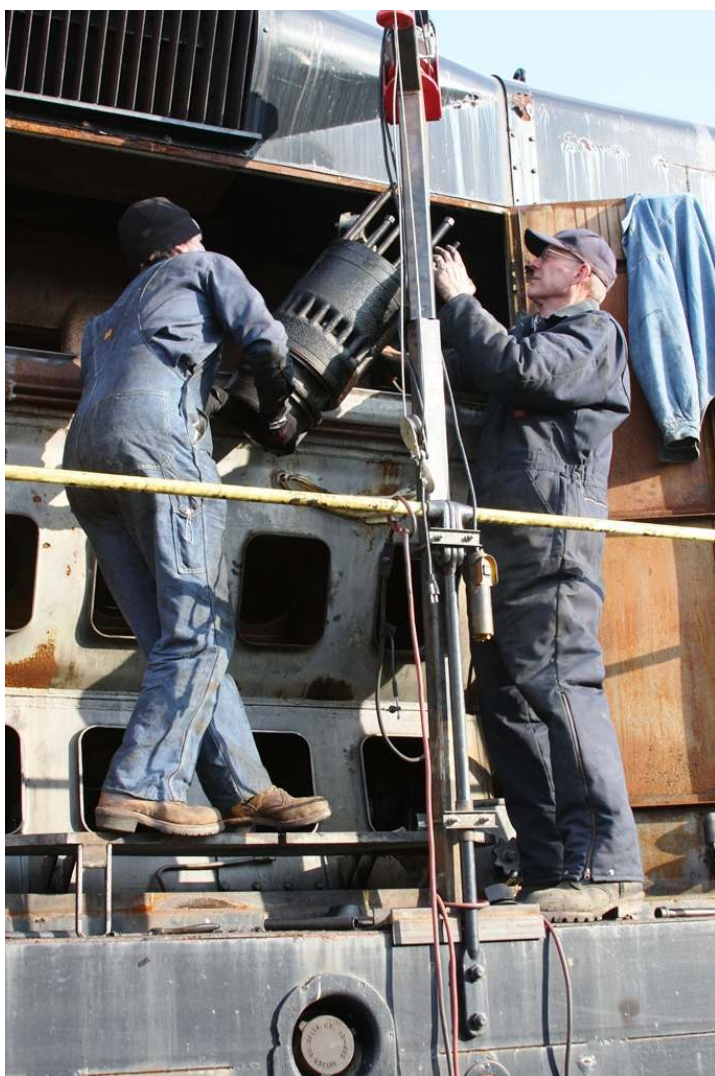
(BOTTOM RIGHT) Swinging the liner clear of the top deck of the engine.
