Regasketing Reading Company GP7 621: *Cylinder Head & Cylinder Liner Removal*

For the second issue of *Shop Talk* we're going to take a look at some ongoing work we've been doing to our GP-7 Number 621. We've recently been working towards returning the 621 to service. Upon our initial inspections in 2009 we found that the engine's cooling system was compromised and that the gaskets which keep the coolant from leaking from the water jacket into the crankcase of the engine had dried out. This caused coolant to leak into the engine's oil. The fix for this is not overly expensive as far as materials go; However, there is a significant amount of labor that goes into removing all of the components from the engine to reach the leaky gaskets. After all the components are removed they need to be thoroughly cleaned and qualified before their reinstallation.

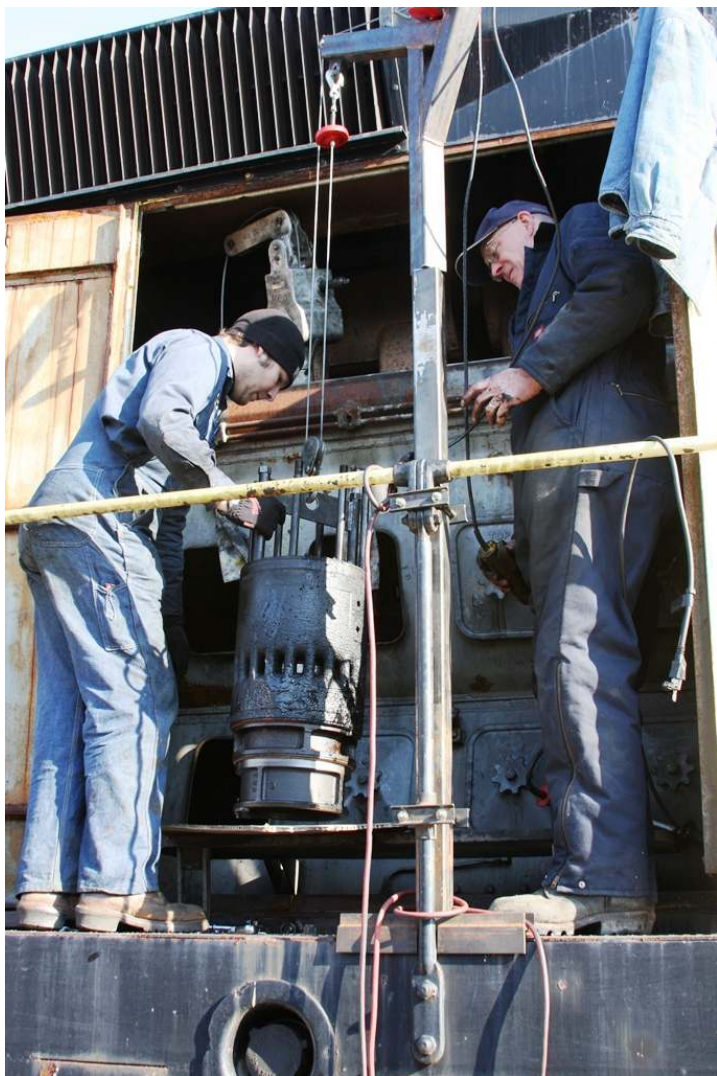
(TOP LEFT) After it's clear of the block, the liner is lowered to the running board and picked up by the hand-rail crane.

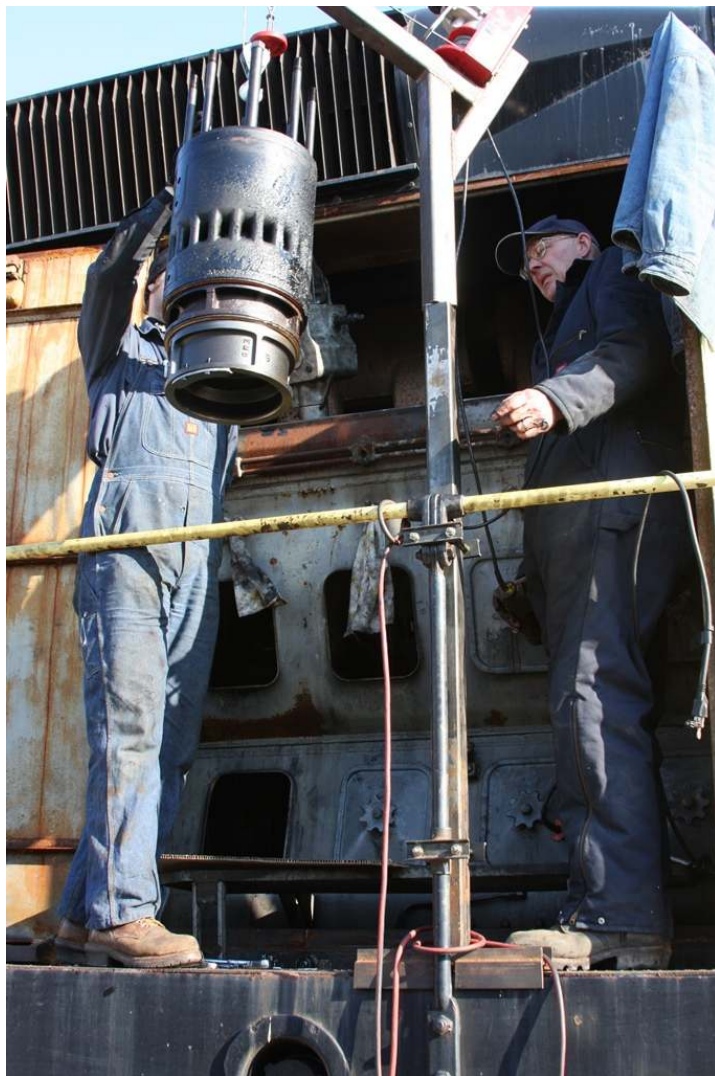
(TOP RIGHT) The hand-rail crane swings the liner from the running board out over the edge of the engine to be lowered to the ground.

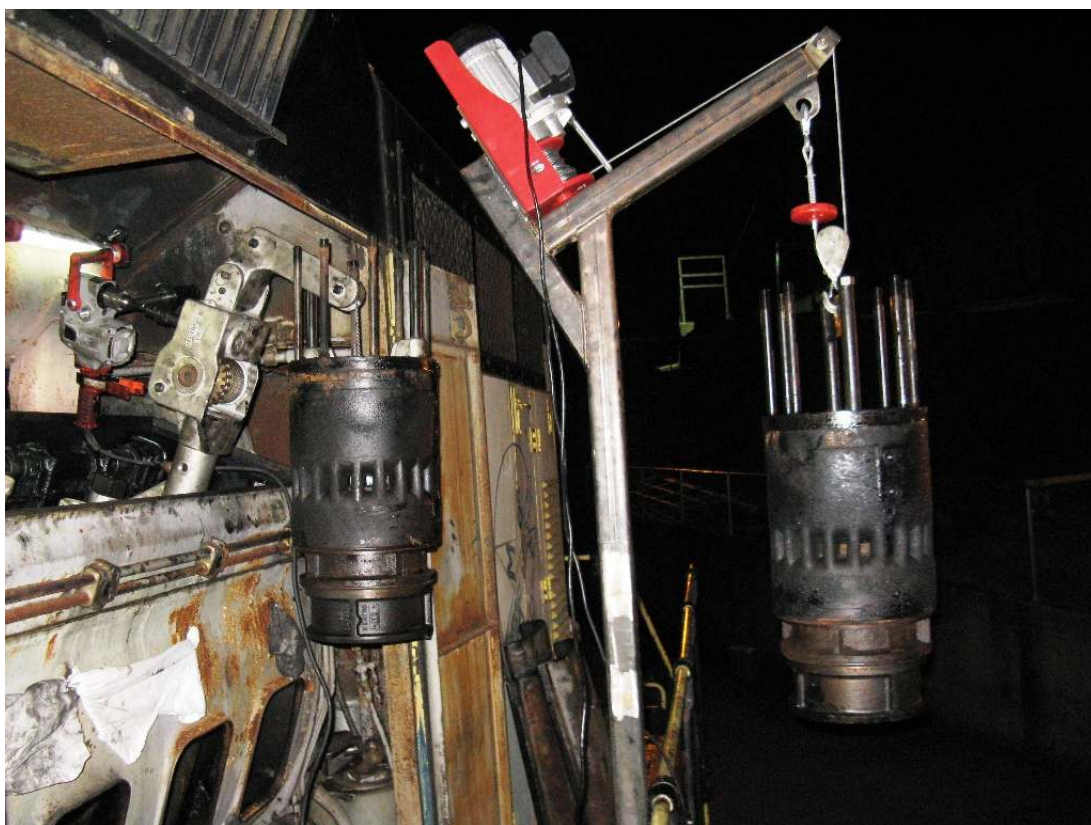
(BOTTOM) Two liners removed and hanging from both the top deck and handrail cranes.

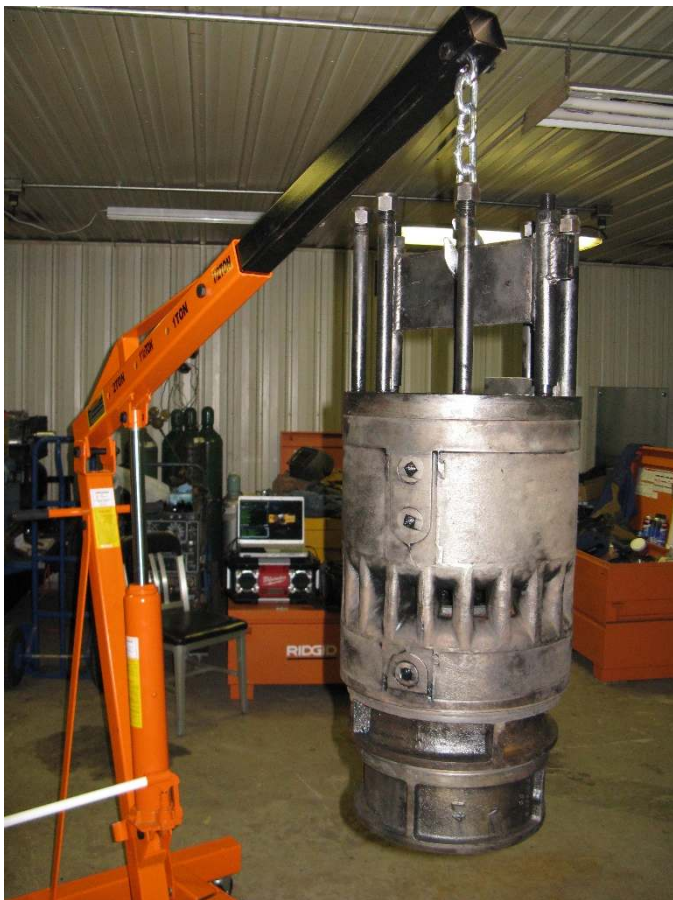
(TOP LEFT) After the liners are removed and moved into our work area, they are then cleaned while hanging from the shop crane.

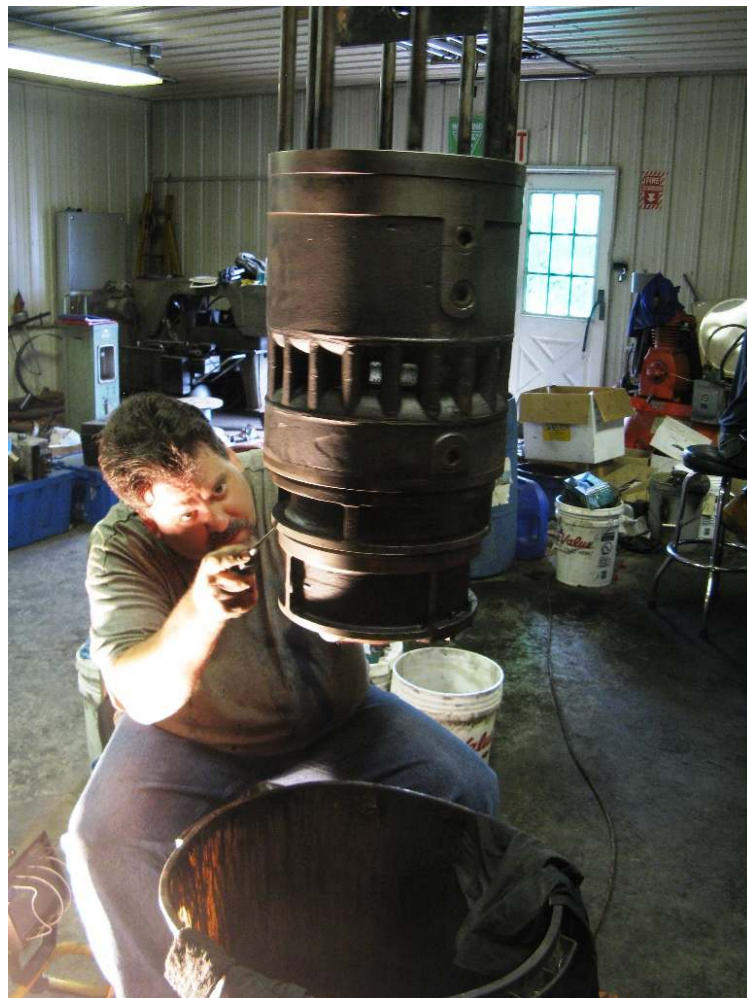
(TOP RIGHT) Here volunteer Rich cleans a liner's gasket seat. This is a very important part of the process. When the old gaskets come off in multiple pieces, they leave chunks behind still adhered to the liner. All those remnants need to be removed to ensure proper seating of the new gaskets.

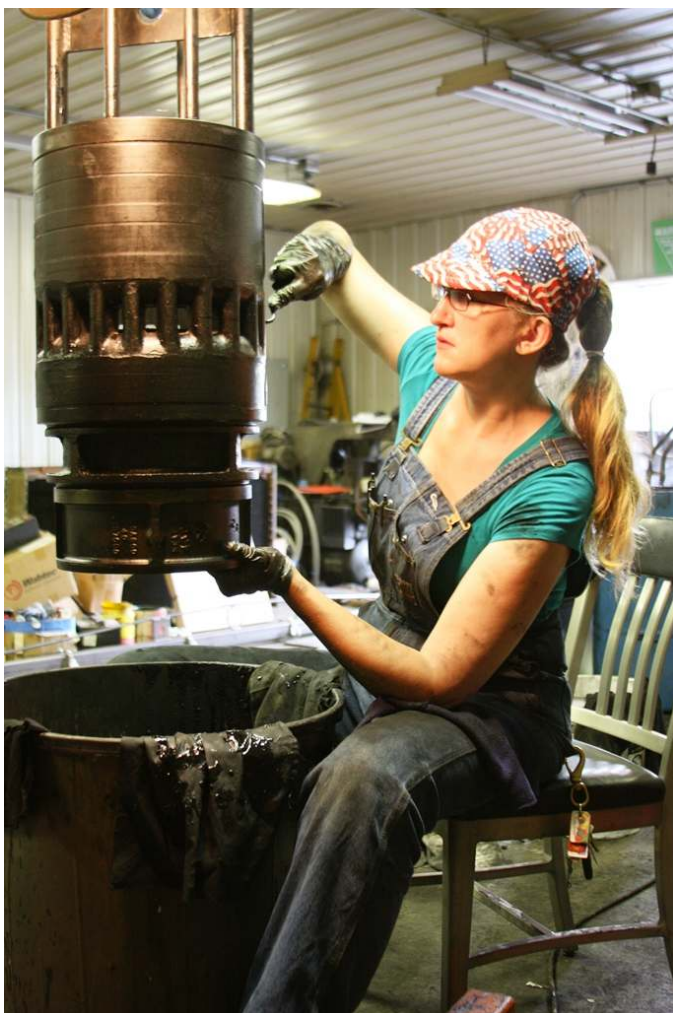
(BOTTOM) Volunteer Monika scrapes away years of build-up from the outside of the liner's intake ports. Because the EMD is a two-stroke engine, the piston acts as its own intake valve when it clears these ports. Build-up around these ports will naturally starve the engine from proper intake air flow.
